# DDR Touble Shooting

ID: RK-PC-YF-043

Release Version: V1.0.1

This document provides the DRAM debug method, which is suitable to all Rockchip chips.

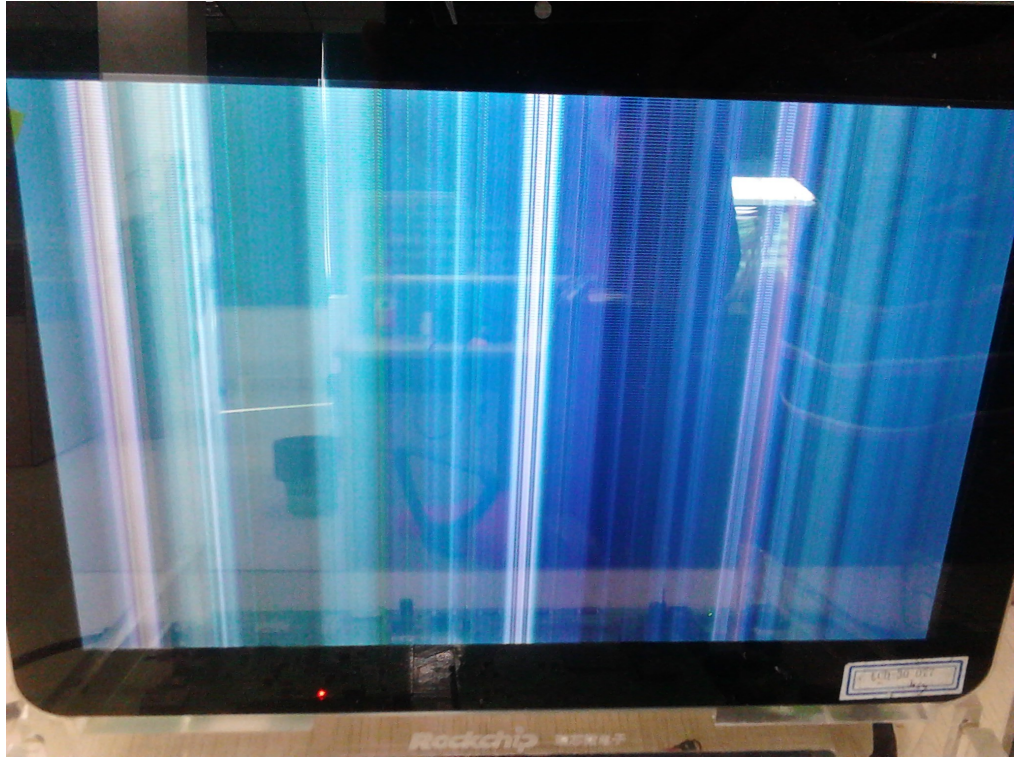
1. If display normal, it means that the DDR can be accessed normally, but it does not mean that the crash is not related to the DDR.
2. If display by mistake:
  - As the picture as shown below, it may be that the DDR is in an inaccessible state during the DDR frequency scaling process. At this time, you can try fixing the DDR frequency. Or it may

be DDR controller logically error caused by power issue.

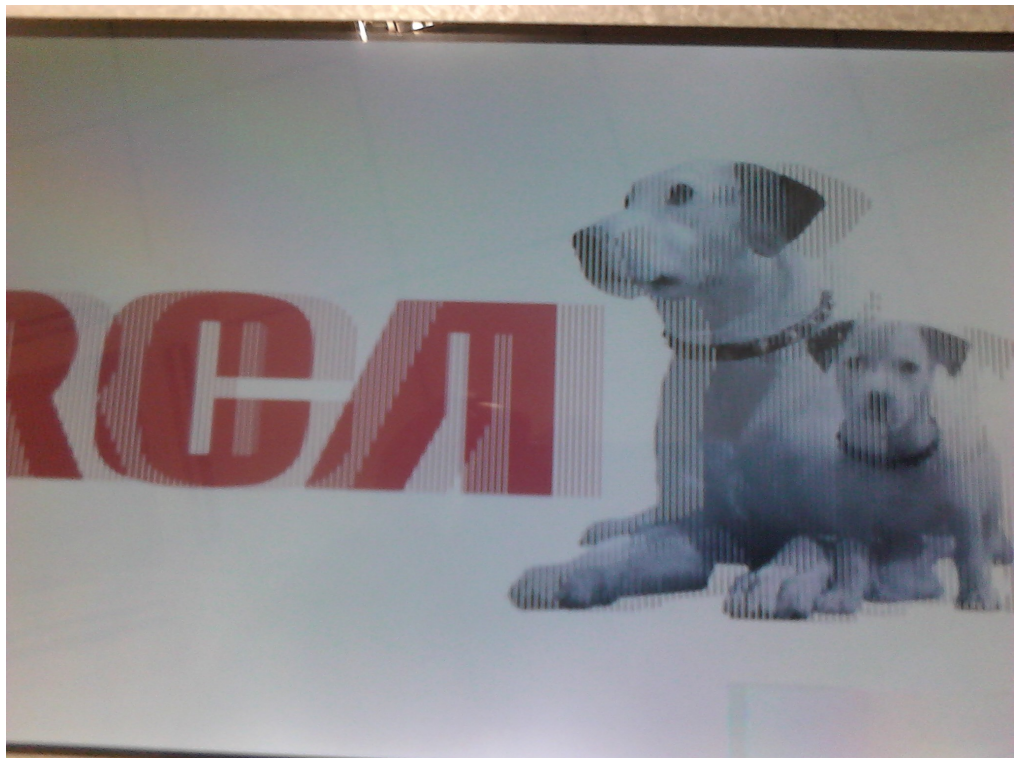
- As shown picture below, we call it "Ghosting", there is a similar situation triggered by the incomplected reference layer of the board. The way to fix it is trying raise the `VCC_DDR` voltage to 1.6V or bypassing the dll of DDR.
